PROPERTY CONDITION REPORT

Inspection Prepared For: John Q Investor

Date of Inspection: 6/3/2019 - Time: 10:00 AM

Year Built: 2012 - Size: 98 Rooms

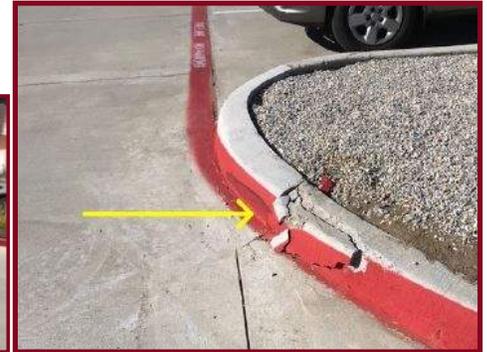
Concrete curbing was observed to be damaged adjacent to the front entry to the building. Condition should be further evaluated and corrected as necessary.

DAMAGED CURBING

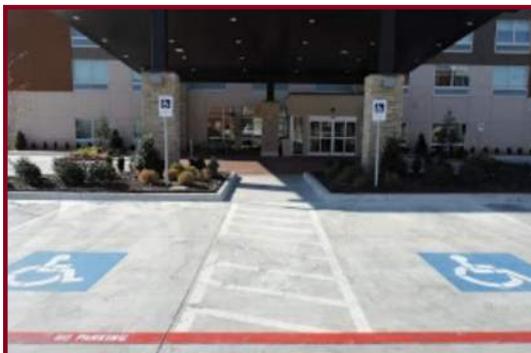
There were not enough handicap accessible parking spaces in place in relation to the amount of regular parking spaces provided. (See Chart Below)

HANDICAP PARKING

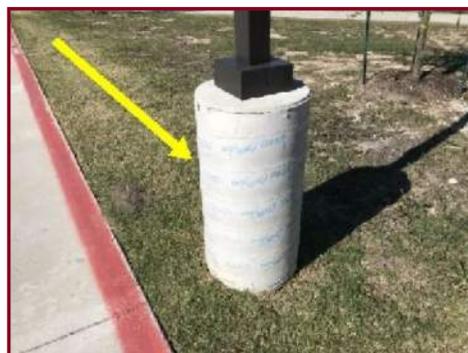
The sono-tube (concrete form) has not been removed from the base of one of the area light poles.

AREA POLE LITE NEEDS SONO-TUBE REMOVED

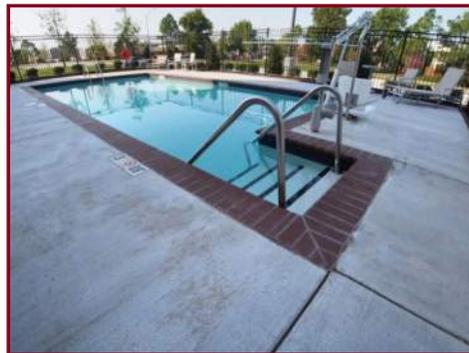
There are some visible deficiencies observed in the pool finished surface at this time. Some resurfacing may be necessary within the next 5 years.

SWIMMING POOL

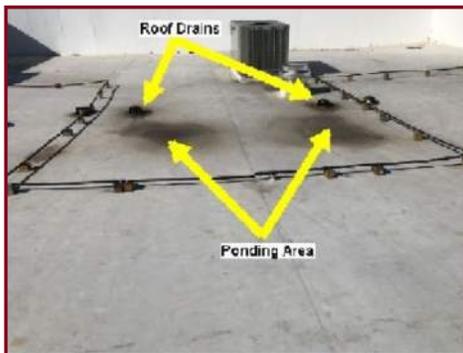
The flat roof area has standing water and stains caused by standing water. Flat roof structures should not hold water more than 24-hours. This condition should be closely monitored and improved as necessary.

STANDING WATER ON ROOF

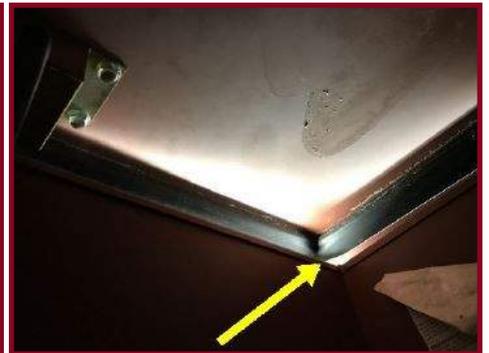
The roof hatch did not properly seal at the time of the inspection. (See Picture) Condition should be further investigated and corrected as necessary.

ROOF HATCH DOES NOT SEAL

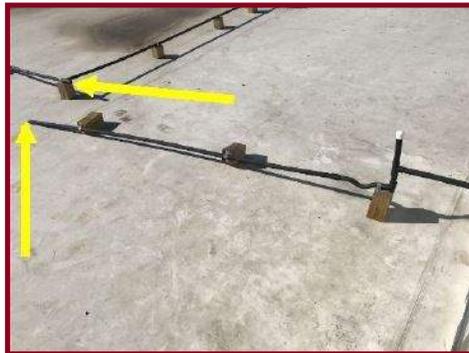
The **condensate lines** to the **RTU**'s were observed to be broken/detached in several locations on the roof. Condition should be further evaluated and corrected as necessary.

DAMAGED/SEPARATED CONDENSATE DRAIN
