PROPERTY INSPECTION REPORT

Client: John Q. Customer
Inspection Address: 1234 WhataRelief Ln
Inside, TX 75111
Year Built: 2004 - Size: 2,715 square feet

Date of Inspection: 12/19/2019 - Time: 1:00 PM
Weather: Sunny - 60 to 70 degrees

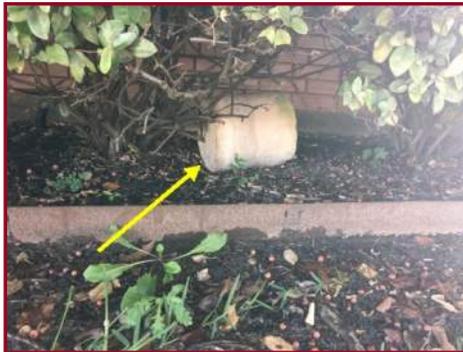
You should be aware that there is visible evidence of previous foundation repairs. You are strongly encouraged to consult the current homeowner on previous foundation work performed and warranty information. Since I have not reviewed the property prior to the foundation work and I was not present at the time the foundation work was performed, an opinion as to whether the work was performed properly and as to whether foundation movement will continue or, if so, the extent of such movement cannot be rendered.

EXTRA CONCRETE CYLINDER APPARANTLY LEFT OVER FROM PREVIOUS FOUNDATION REPAIR

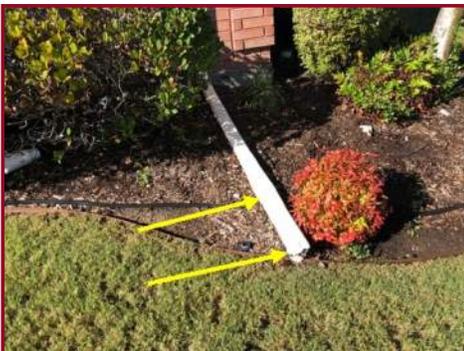
The guttering system downspout extension is damaged on the East Side of the structure.

GUTTER EXTENSION DAMAGED

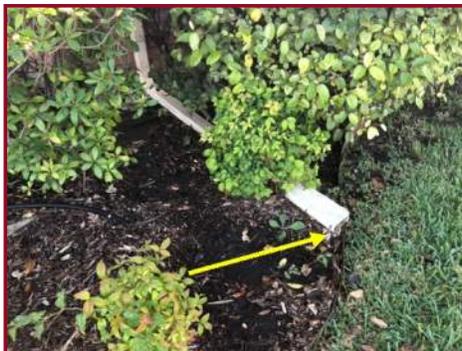
DAMAGED DOWNSPOUT EXTENSION

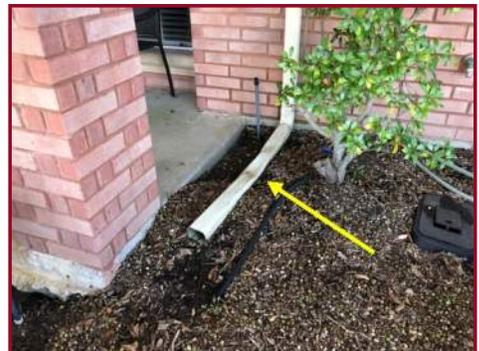
DAMAGED DOWNSPOUT EXTENSION

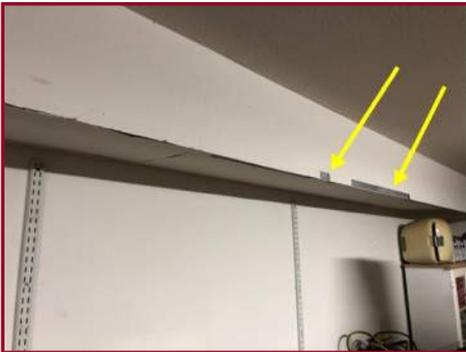
Corner beam was observed to be damaged/missing in the garage area.

CORNER BEAD PLASTER FLAKING IN GARAGE

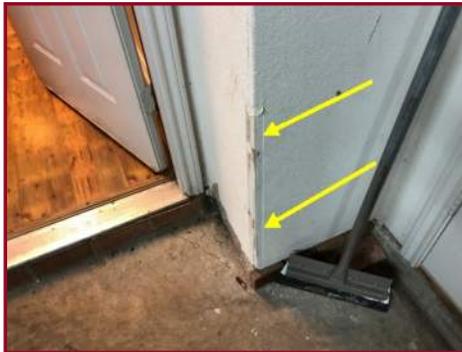
CORNER BEAD MISSING IN GARAGE

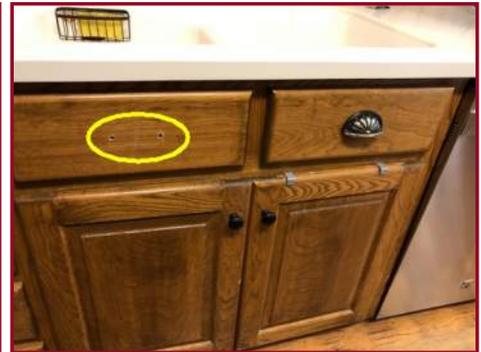
Cabinet hardware was observed to be missing on the drawer front below the kitchen sink.

MISSING CABINET HARDWARE IN KITCHEN

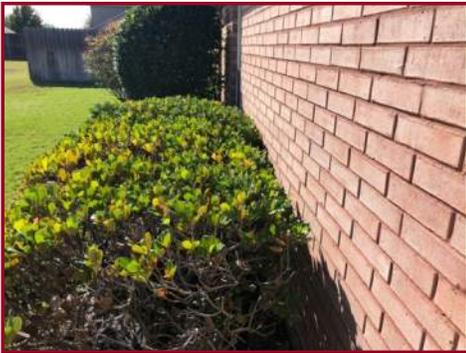
HEAVY FOLIAGE SHOULD BE TRIMMED BACK AWAY FROM WALL

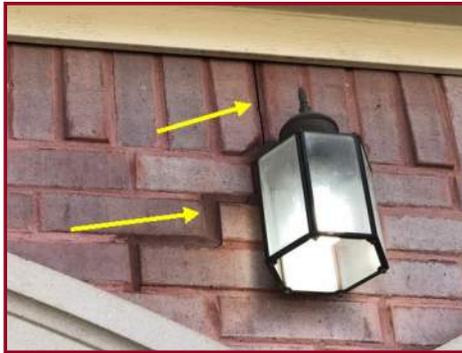
Mortar cracks in the veneer were observed on the East Side of the structure over the north arch. The arch appears to have settled more than normal. **Luckpointing** is recommended. If any cause of concern is noted on this report, or if you want further evaluation, you should consider an evaluation by an engineer of your choice.

MORTAR CRACKS ON EAST SIDE

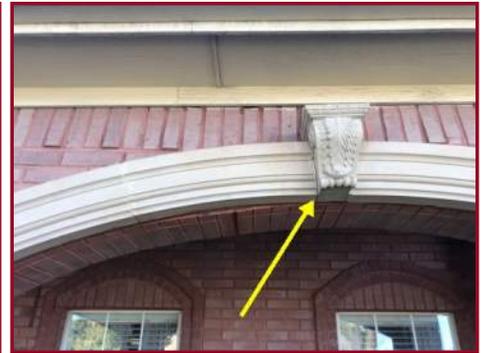
ARCH ON FRONT PORCH IS SAGGING

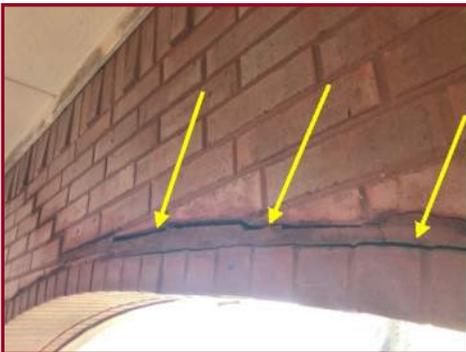
MORTAR CRACKS AT ARCH OVER FRONT PORCH

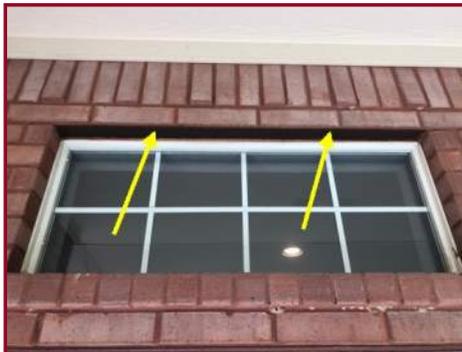
The steel **linte**s over the exterior doors and windows need to be painted. The expansion of rusting steel lintels can cause cracks above the opening.

STEEL LINTELS NEED PAINT

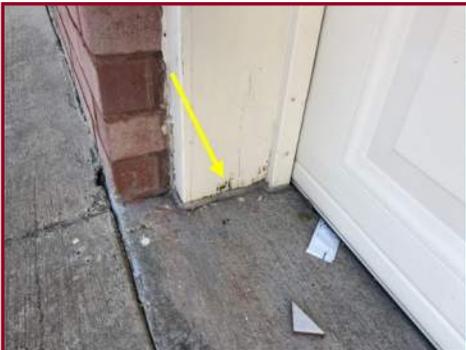
The garage door trim has some deterioration and/or damage at the bottom. The trim is touching the ground. This trim should be trimmed up 1 inch so not to absorb water.

GARAGE DOOR TRIM DAMAGE

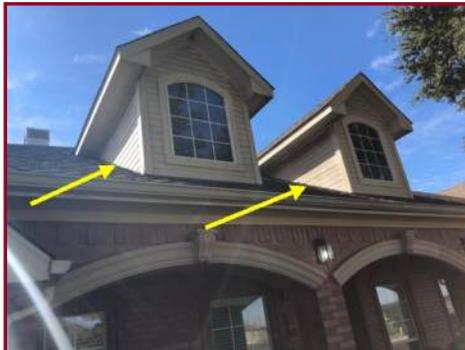
The sidewall veneer / cladding is in contact with the roofing material. Under current building standards, there should be at least 2-inch of clearance between the roofing material and the sidewall veneer / cladding. This is an "as-built" condition but Per TREC standards of practice we are required to report this condition as a deficiency

SIDEWALL VENEER IN CONTACT WITH ROOF

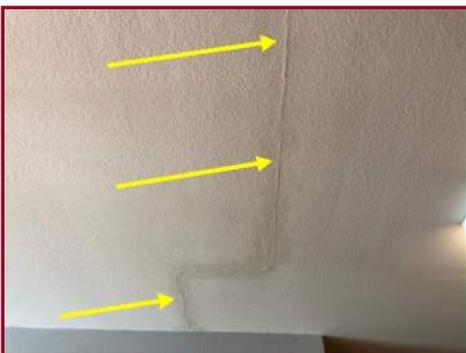
Ceiling stress cracks were observed in the upstairs gameroom, master bathroom, kitchen

CEILING STRESS CRACKS IN KITCHEN

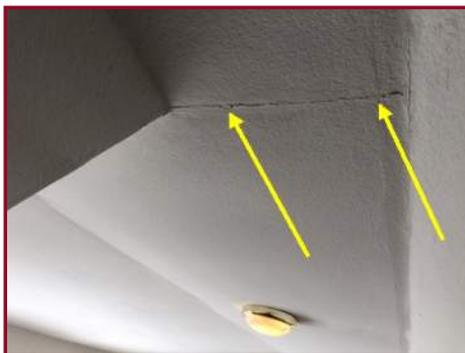
CEILING STRESS CRACKS IN GAME ROOM CEILING

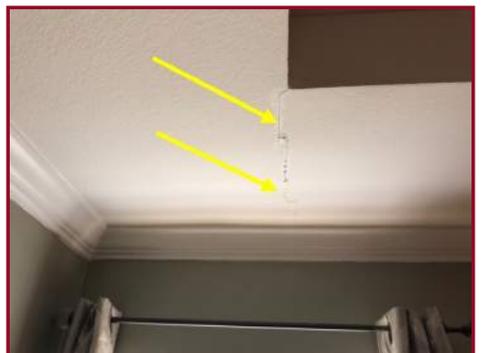
CEILING STRESS CRACKS IN MASTER BEDROOM

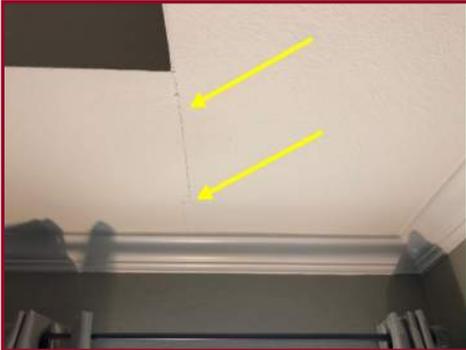
CEILING STRESS CRACKS IN MASTER BEDROOM

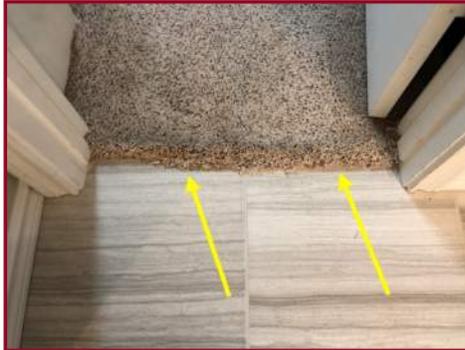
The carpeting is pulling up and needs to be stretched and tucked where the carpet meets floor tile at the master bathroom entry and the master closet entry.

CARPETING NEEDS TO BE STRETCHED AND TUCKED AT MASTER CLOSET DOOR

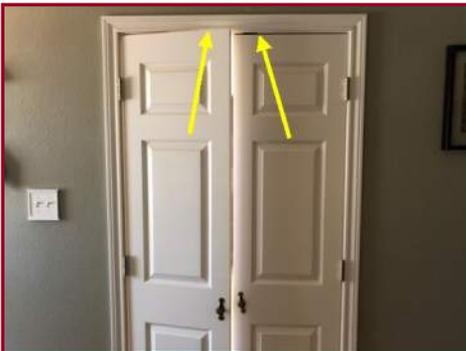
SPRING LATCH NOT FUNCTIONING PROPERLY ON MASTER BATHROOM DOORS

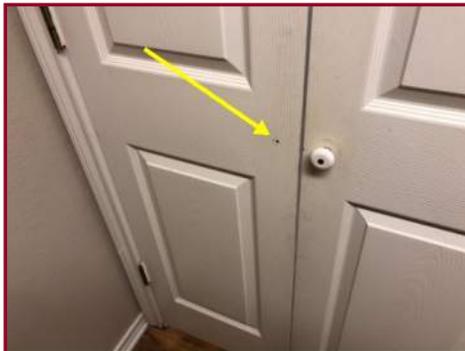
The door pull is missing to the utility room/master bedroom hallway door.

HARDWARE MISSING ON DOORS TO MASTER BEDROOM HALLWAY

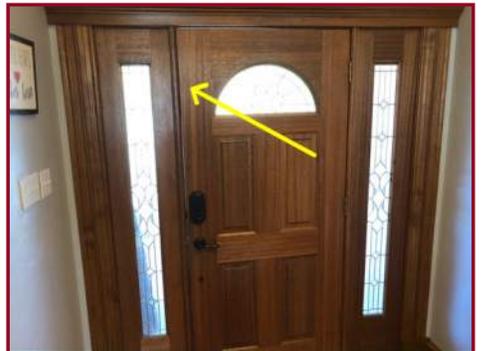
DOOR IS RUBBING THE JAMB TO THE FRONT ENTRY

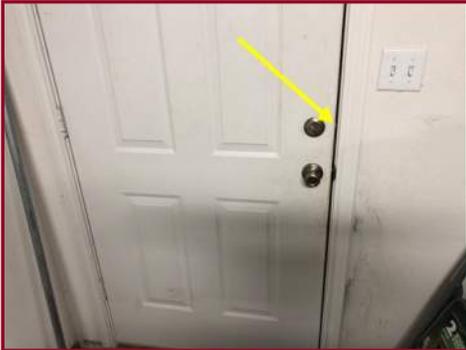
DEADBOLT NOT LATCHING PROPERLY ON GARAGE REAR ENTRY

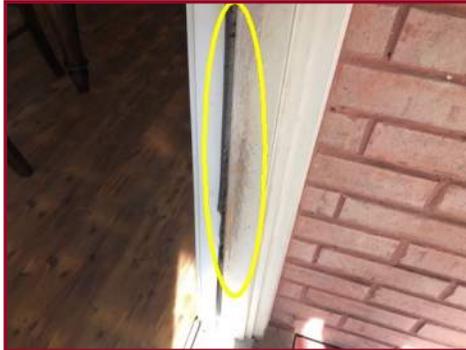
The door frame has some damage from dog scratching to the backyard entry.

DOOR FRAME DAMAGE ON REAR ENTRY DOOR

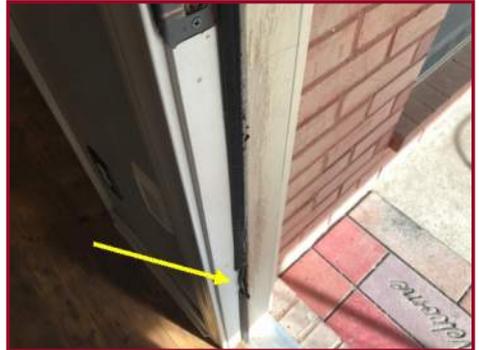
WEATHERSTRIPPING DAMAGED/MISSING ON REAR ENTRY DOOR

Weather-stripping improvements are recommended for the backyard entry exterior door(s).

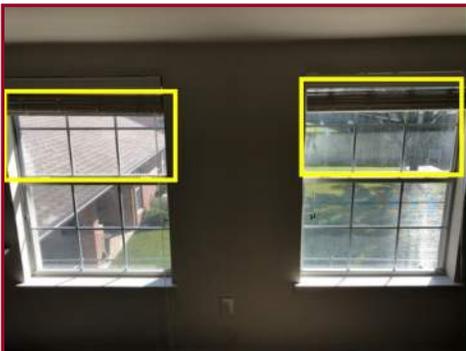
One or more of the **thermal pane** windows were observed to have lost their seals. This has resulted in condensation or a fog like film to develop between the panes of glass. The thermal pane windows no longer function as designed when they loose their seal and replacement may be necessary. The windows that have noticeably lost their seals are listed but may not be limited to the following locations:
 Upstairs Gameroom, South Middle Bedroom, **Dormer** Windows in Attic.
 Total # of Units: 6

SOUTH WINDOWS HAVE LOST SEAL IN GAME ROOM
 REI 7-5 (05/4/2015)

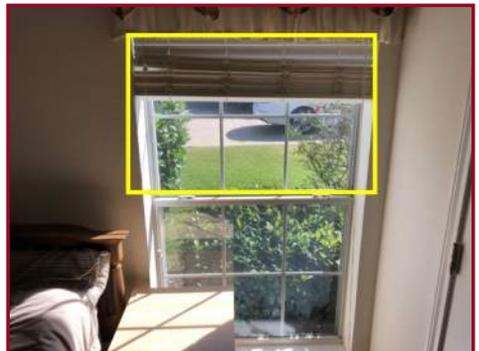
WINDOW HAS LOST SEAL IN SOUTH MIDDLE BEDROOM

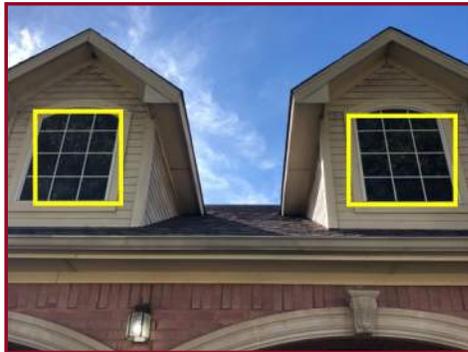
WINDOWS HAVE LOST SEAL

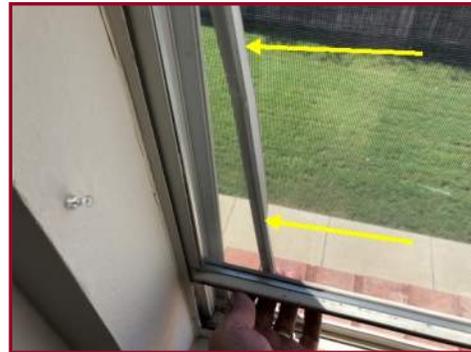
The window **glazing bead** is pulling loose at the west window in the upstairs gameroom. Improvements are recommended.

GLAZING BEAD LOOSE ON WEST WINDOW IN GAME ROOM

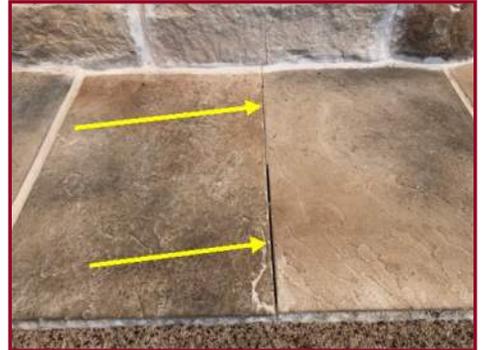
The **hearth extension** outside of the firebox as well as the rock face has some cracks and repairs may be necessary.

CRACKED/DETERIORATED GROUT ON HEARTH

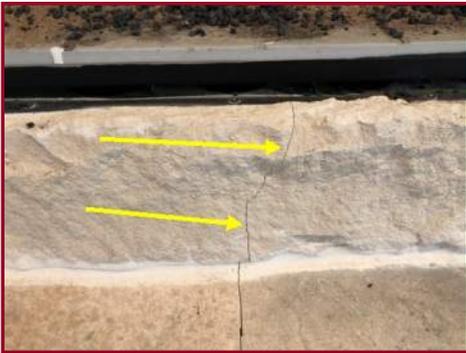
CRACK ON FACE OF FIREPLACE BELOW FIREBOX

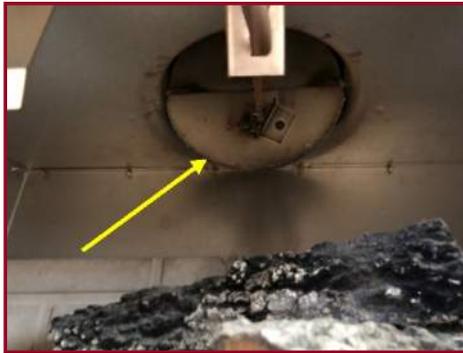
DAMPER CLAMP NEEDED

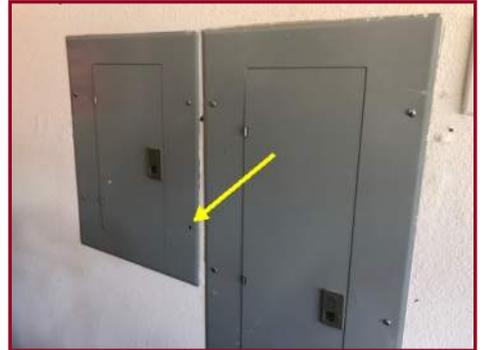
The dead front cover on the sub panel has missing screws. Recommend replacing the screws that are missing with the correct blunt tip screws

COVER PLATE MISSING SCREWS

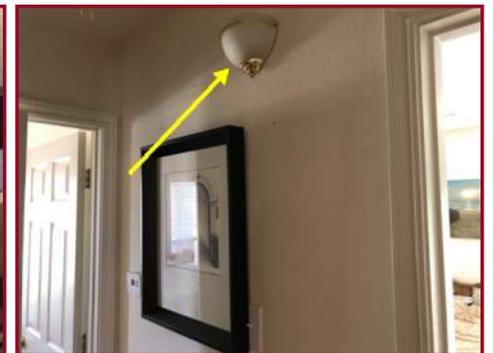
One or more of the light fixtures appear to be inoperative in the master bedroom closet, bedroom hallway. This may be due to a bad bulb or some other unknown condition. This condition should be further evaluated and corrected as necessary.

INOPERATIVE LIGHT FIXTURE IN BEDROOM HALLWAY

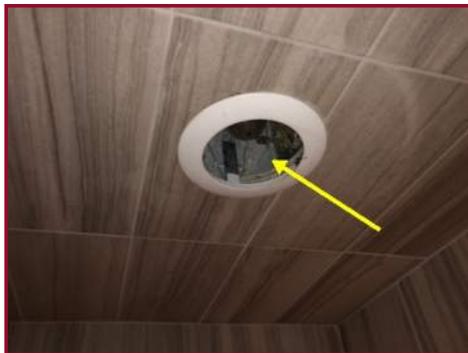
One or more of the light fixture globes and/or covers are missing in the kitchen, master bathroom shower.

LENSE TO THE CAN LIGHT IS MISSING IN MASTER BATHROOM SHOWER

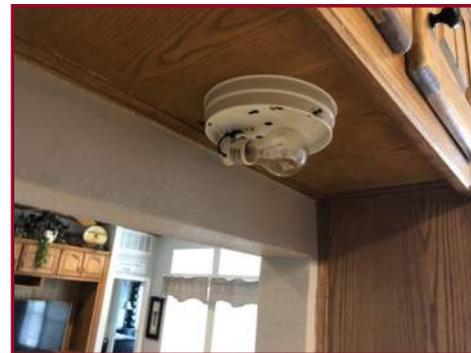
MISSING COVER TO LIGHT FIXTURE OVER KITCHEN SINK

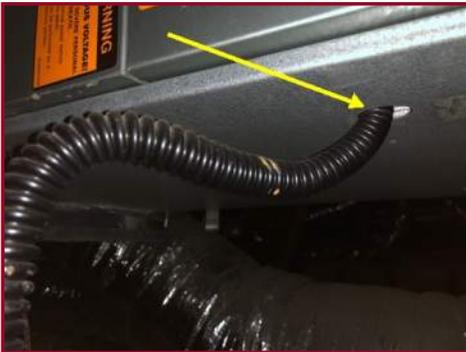
The gas supply flex connector on all three units was observed to be passing through the heating unit cabinet. Under current mechanical installation standards, this is no longer an accepted practice. Only rigid black gas pipe is allowed to pass through the heating unit cabinet.

FLEX CONNECTOR ENTERS CABINET

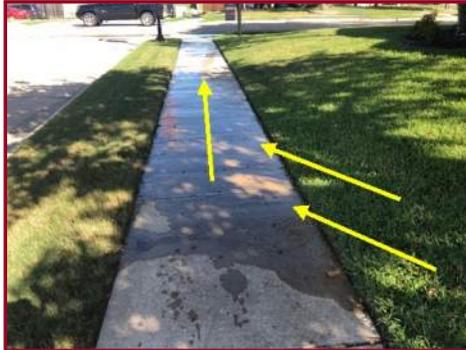
WATER LEAKING FROM SEWER DOWN SIDEWALK

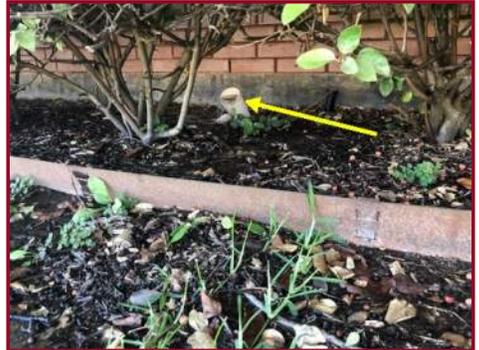
SEWER CLEANOUT ON NORTH SIDE OVERFLOWING

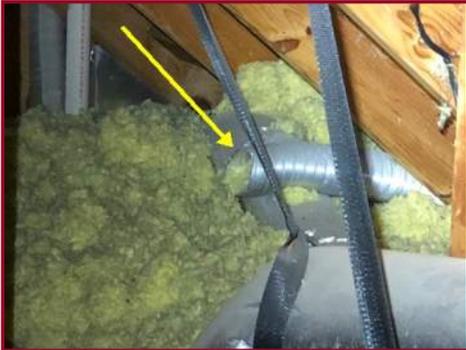
MECHANICAL EXHAUST VENTS EXIT INTO ATTIC

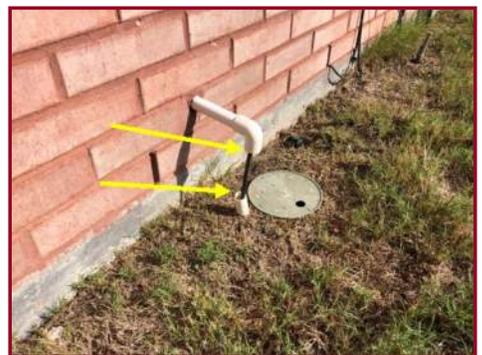
The conduit that is protecting the sprinkler system wires is damaged.

DAMAGED CONTROL WIRE CONDUIT
