# PROPERTY CONDITION REPORT

**Client: Ultimate Properties**  
**Property: 9940 Sunset Strip, Anywher, TX 75111**  
**Year Built: 1995 - Size: 3,385 square feet**

**Date of Inspection: 8/6/2018 - Time: 9:00 AM**  
**Weather: Partly Cloudy - 70+ degrees**

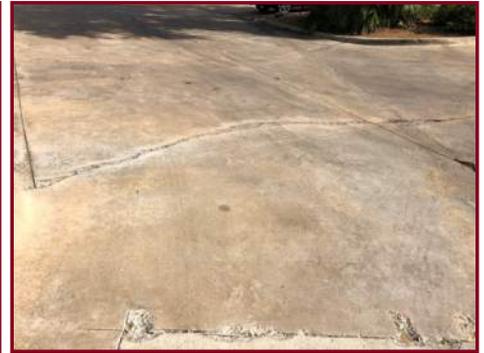
MINOR CRACKS IN PAVEMENT

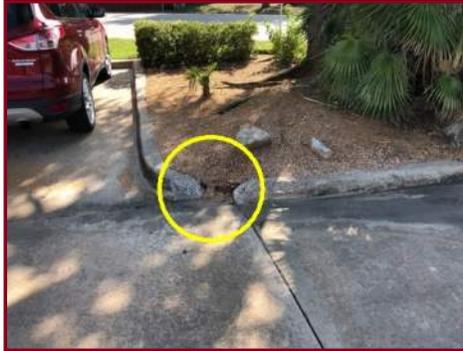
Concrete curbing was observed to be damaged at the landscape area east of the main driveway access. Condition should be further evaluated and corrected as necessary.

DAMAGED CURB ADJACENT TO ENTRANCE DRIVE

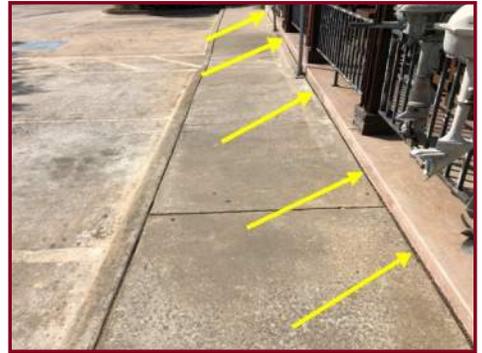
Some settlement between the sidewalk and the outside dining patio has occurred. The joint between the sidewalk and the patio should be sealed to prevent water intrusion and further settlement.

JOINT BETWEEN PATIO AND SIDEWALK SHOULD BE SEALED

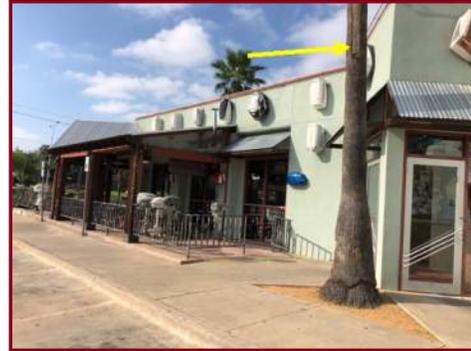
The palm tree located at the main entrance to the subject building appears to be dead and needs replacement.

THE PALM TREE AT THE MAIN ENTRANCE APPEARS TO HAVE DIED

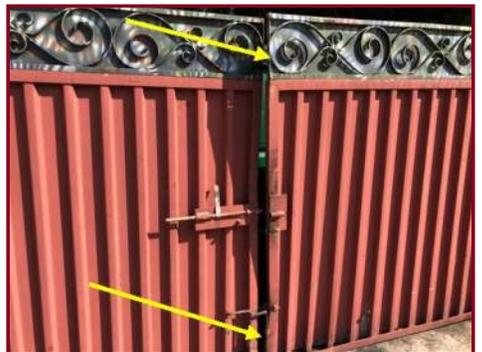
The gates to the waste storage area appear to be sprung and are in need of adjustment.

GATES ARE SPRUNG AND OUT OF ALIGNMENT

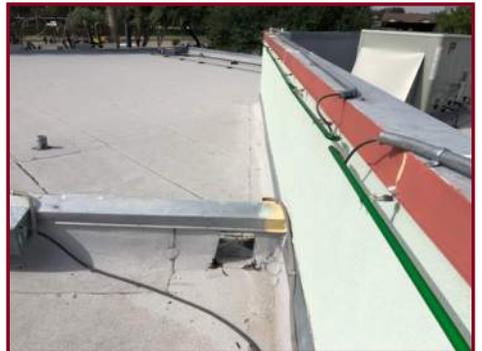
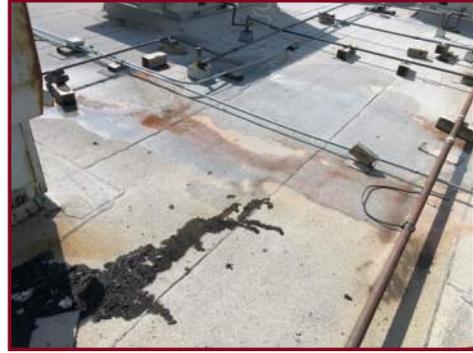
The flat roof area has standing water. Ponding and/or standing water can be caused by factors such as inadequate drainage, deflection of structure and insufficient slope. Flat roof structures should not hold water more than 24-hours. This condition should be closely monitored and improved as necessary.

Note: The **condensate line**s to the **HVAC** units was cut allowing condensation to drain onto the roof surface. This condition appears to be the cause for excess water on the roof.

STANDING WATER ON ROOF

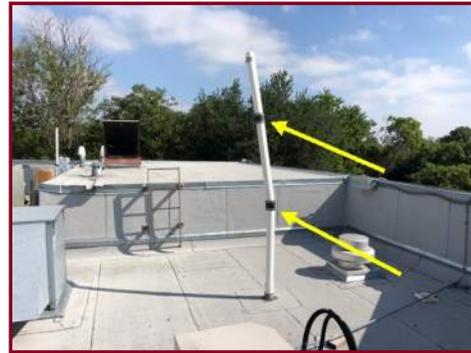
A plumbing vent extension on the roof was observed to be held together by rubber couplings allowing the **vent pipe** to flex. Rubber couplings should be replaced with rigid PVC couplings.

PLUMBING VENT NEEDS PROPER PVC COUPLINGS

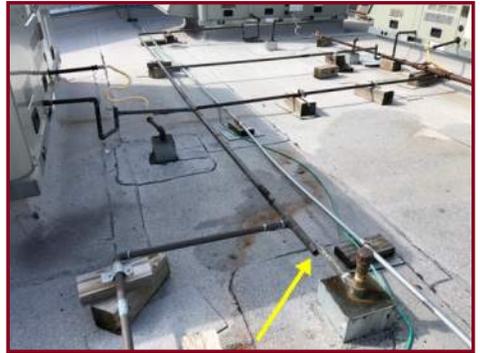
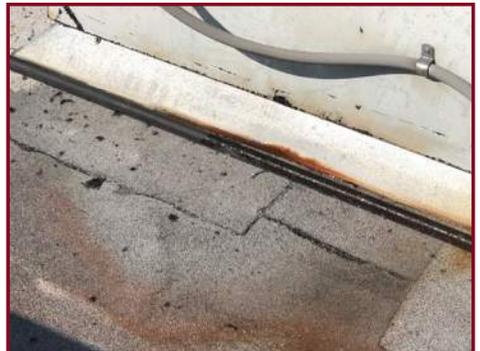
The condensate line draining all four units was observed to be cut in two just before it enters the drain, allowing the condensate to drain onto the roof surface. Condensation from HVAC units should drain to the sanitary sewer. Condition should be further evaluated and corrected as necessary.

CONDENSATE DRAIN HAS BEEN CUT

HVAC CONDENSATE LINES LEAKING ON ROOF

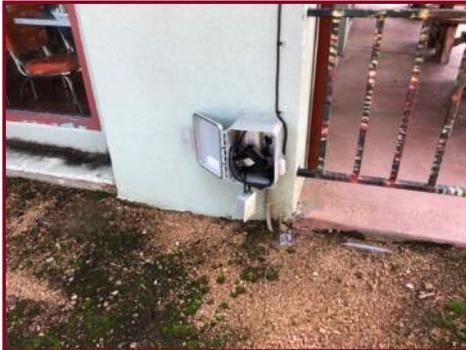
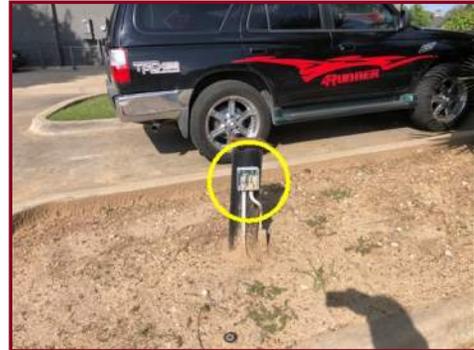
Open junction boxes were observed in the north landscape areas. All exterior junction boxes should be sealed for reasons of safety.

OPEN JUNCTION BOX IN NORTH LANDSCAPE AREA

OPEN JUNCTION BOX IN FRONT LANDSCAPE AREA

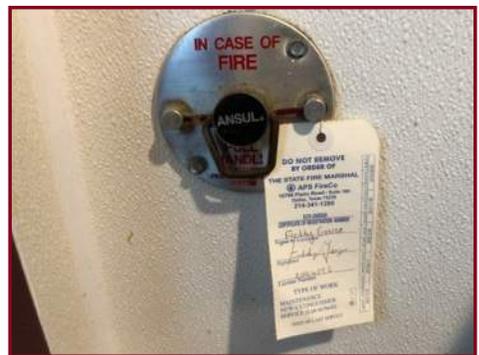
The inspection tag to the pull station for the fire suppression equipment in the kitchen vent hoods was observed to be out of date.

KITCHEN VENT HOOD FIRE SUPPRESSION PULL STATION

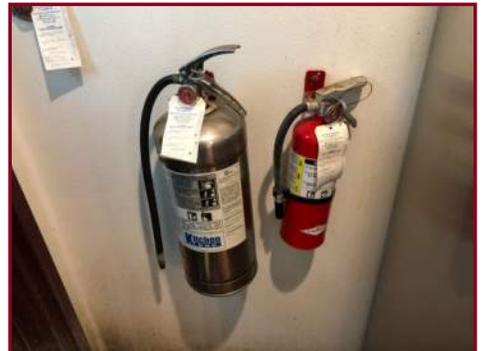
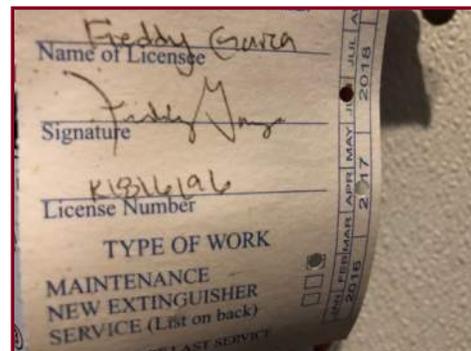
**Inspection Tags were observed to be out of date.**

FIRE EXTINGUISHER INSPECTION TAG

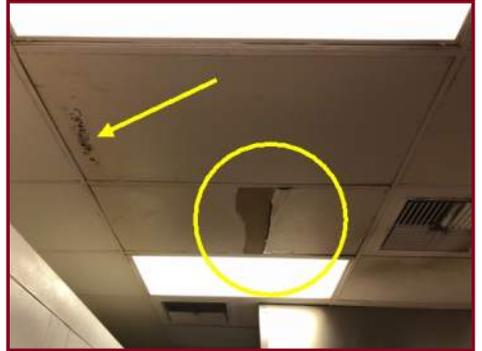
Some of the ceiling tiles in the kitchen were observed to be water damaged. Condition could be caused by condensation or a roof leak. Condition should be further evaluated and corrected as necessary.

MOISTURE DAMAGED  
CEILING TILES IN KITCHEN
