PROPERTY CONDITION REPORT

Client: Ultimate Properties
Property: 9091 Somewhere Ln, Dallas, TX 76493
Year Built: 2020 - Size: 83,376 square feet

Date of Inspection: 12/1/2020 - Time: 11:00 AM
Weather: Sunny - 50 to 60 degrees

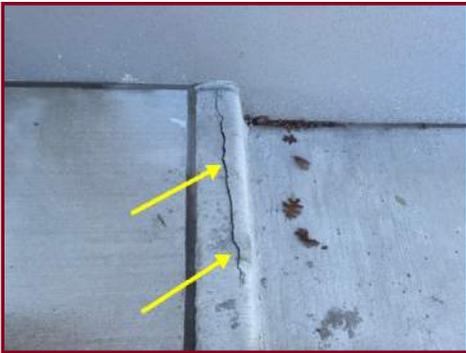
The curbing was observed to be cracked/damaged on the south end of the truck bay parking lot. Condition should be further evaluated and corrected as necessary.

CRACKED/DAMAGED CURB
RIGHT OF FIRE RISER ROOM

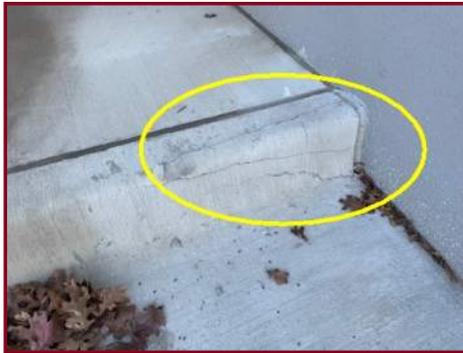
CRACKED/DAMAGED CURB
RIGHT OF FIRE RISER ROOM

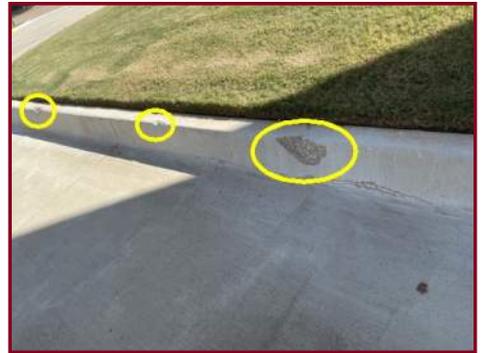
DAMAGED CURB AT SOUTH
END OF TRUCK BAY DRIVE

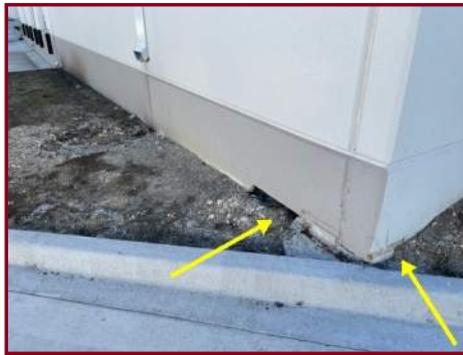
Erosion was observed at the foundation at the northeast corner of the structure. Fill dirt and foliage should be installed to prevent possible foundation settlement.

EROSION AT NORTHEAST CORNER FOUNDATION

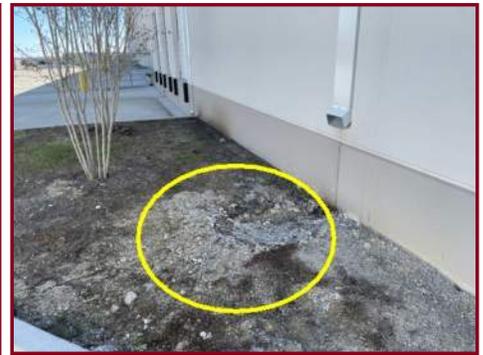
Soil erosion was observed under the **downspout** near the northeast corner of the structure. **Splash block** or a concrete flume should be installed to prevent further erosion and possible foundation failure.

EROSION UNDER ROOF DOWNSPOUT NEAR NORTHEAST CORNER

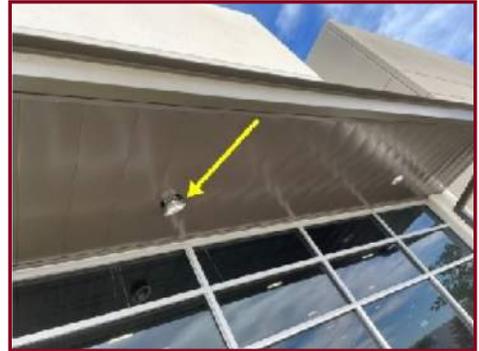
The recessed spotlight in the awning over the main entrance was observed to be loose at its mount.

LOOSE RECESSED SPOTLIGHT IN MAIN ENTRANCE AWNING

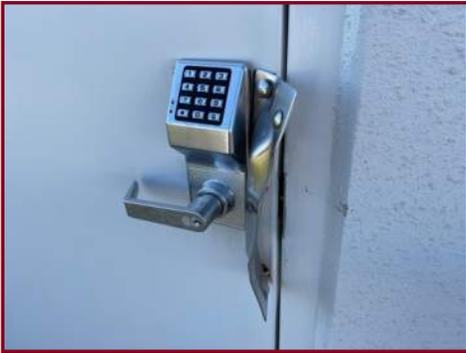
The door lock and door to the fire pump room was observed to have some damage due to vandalism. Condition should be further evaluated and corrected as necessary.

DOOR TO FIRE RISER ROOM HAS BEEN VANDALIZED

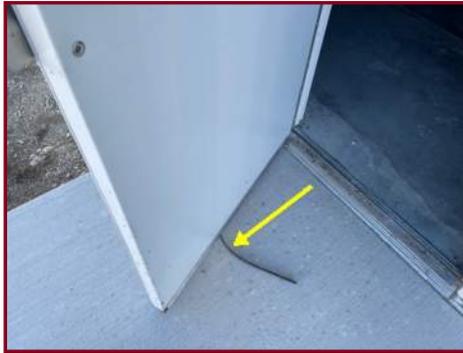
Weatherstripping was observed to be damaged on the bottom of the northeast exit door. Condition should be further evaluated and corrected as necessary.

DAMAGED WEATHERSTRIPPING AT NORTHEAST EXIT DOOR

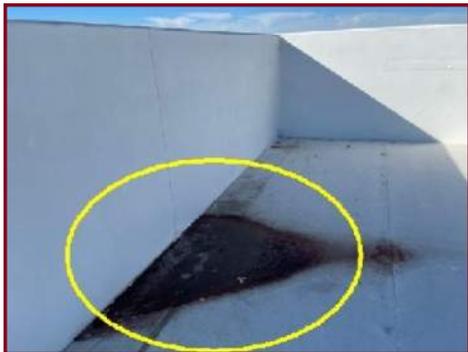
The flat roof area has standing water in various locations. Flat roof structures should not hold water more than 24-hours. This condition should be closely monitored and improved as necessary.

STANDING WATER AT SOUTHWEST CORNER

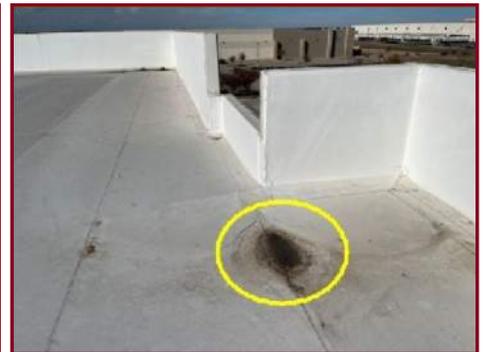
STANDING WATER ON NORTH SIDE

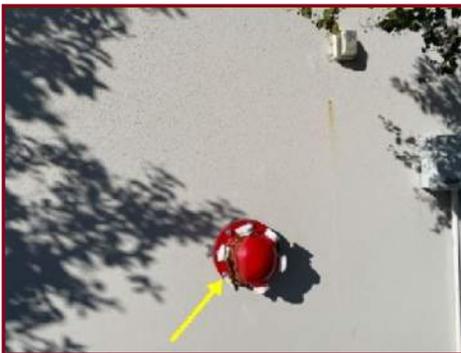
The fireman's exterior hook-up on the exterior wall of the fire pump room was observed to be leaking at the time of this inspection.

FIREMAN'S EXTERIOR HOOK-UP ON EAST WALL IS LEAKING WATER

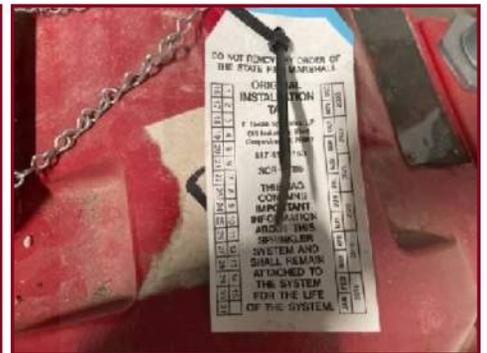
Inspection Tags did not show any previous inspections.

FIRE SPRINKLER TAGS SHOWED NO INSPECTION
