# PROPERTY CONDITION REPORT

**Client: Ultimate Properties**  
**Property: 9940 Sunset Strip, Anywher, TX 75111**  
**Year Built: 1995 - Size: 3,385 square feet**

**Date of Inspection: 8/6/2018 - Time: 9:00 AM**  
**Weather: Partly Cloudy - 70+ degrees**

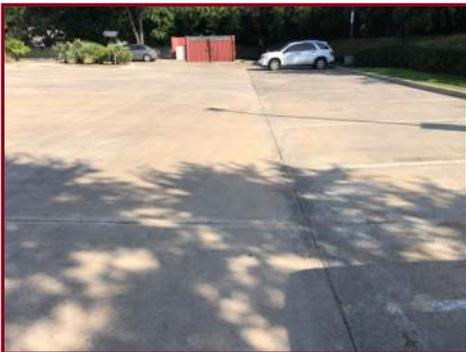
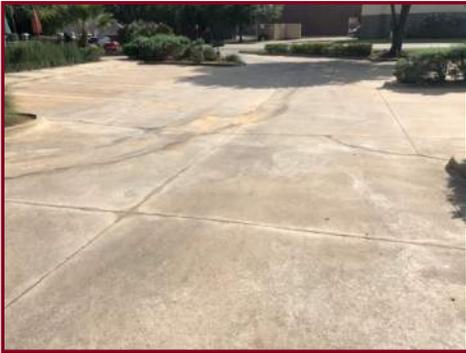
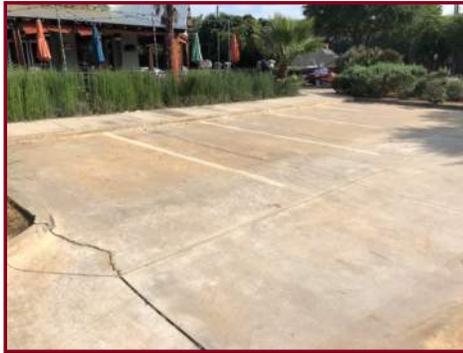
PAVING

Concrete curbing was observed to be damaged at the landscape area east of the main driveway access. Condition should be further evaluated and corrected as necessary.

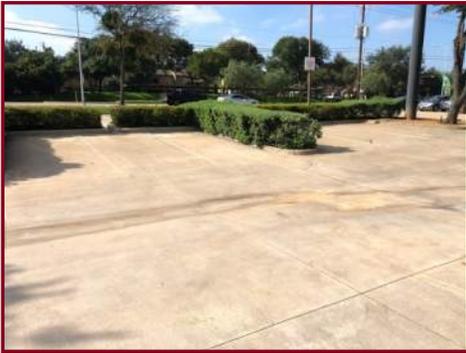
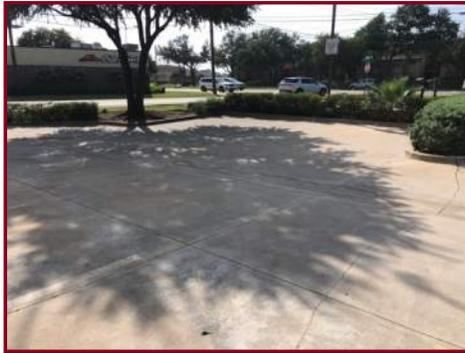
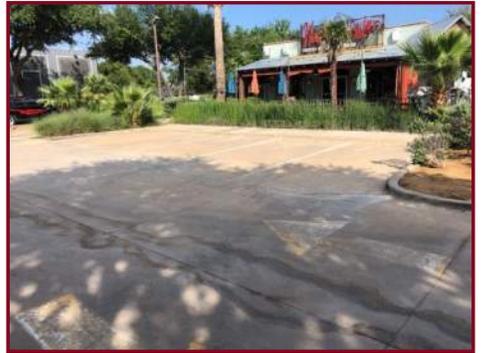
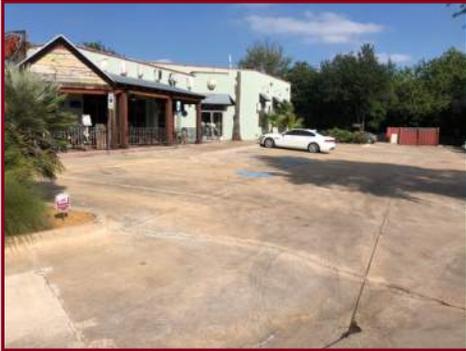
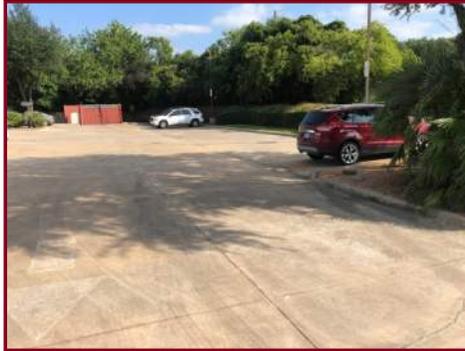
PARKING

**Fire lanes were not marked at the time of this inspection.**

**Parking lot striping was observed to be fading or flaking at the time of this inspection. Striping should be painted in the near future.**

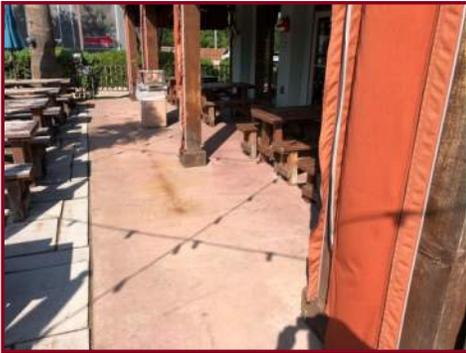
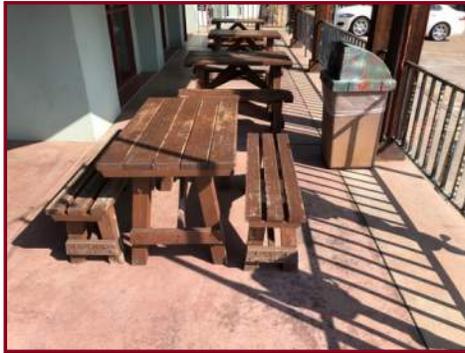
EXTERIOR DINING PATIO

Some settlement between the sidewalk and the outside dining patio has occurred. The joint between the sidewalk and the patio should be sealed to prevent water intrusion and further settlement.

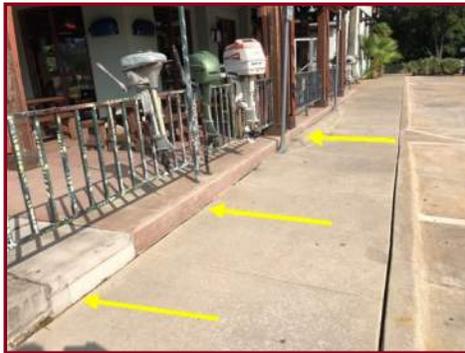
JOINT BETWEEN PATIO AND SIDEWALK SHOULD BE SEALED

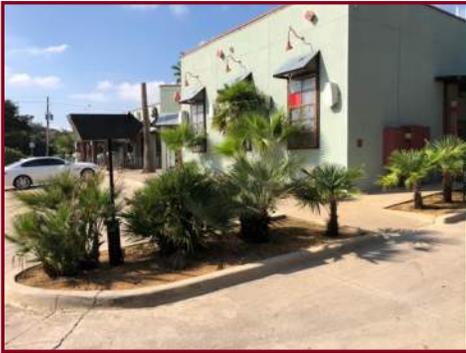
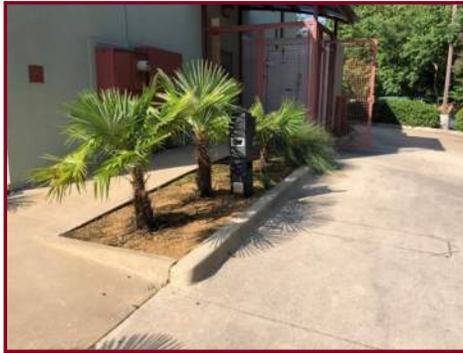
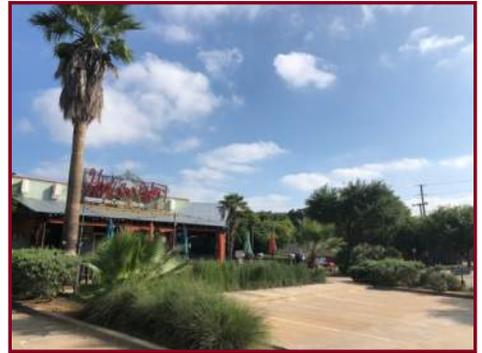
LANDSCAPING

The palm tree located at the main entrance to the subject building appears to be dead and needs replacement.

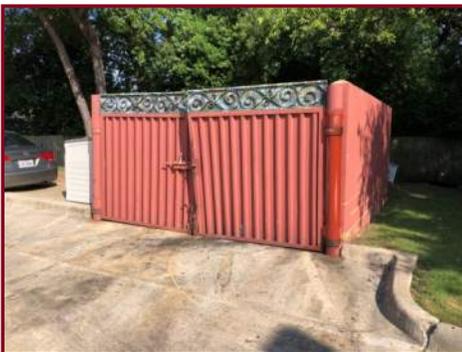
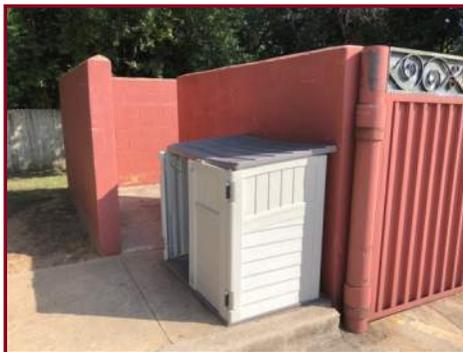
WASTE STORAGE AREA

The gates to the waste storage area appear to be sprung and are in need of adjustment.

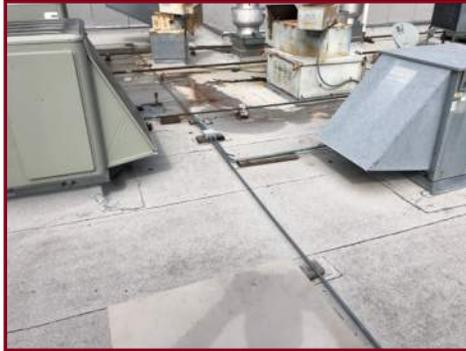
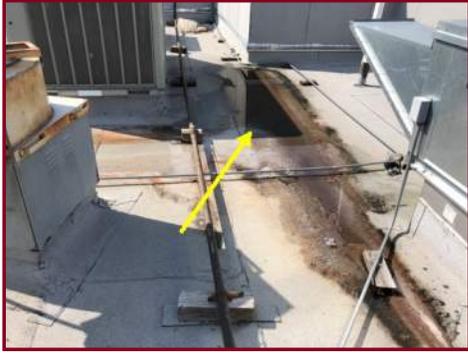
The flat roof area has standing water. Ponding and/or standing water can be caused by factors such as inadequate drainage, deflection of structure and insufficient slope. Flat roof structures should not hold water more than 24-hours. This condition should be closely monitored and improved as necessary.

Note: The **condensate line**s to the **HVAC** units was cut allowing condensation to drain onto the roof surface. This condition appears to be the cause for excess water on the roof.

STANDING WATER ON ROOF

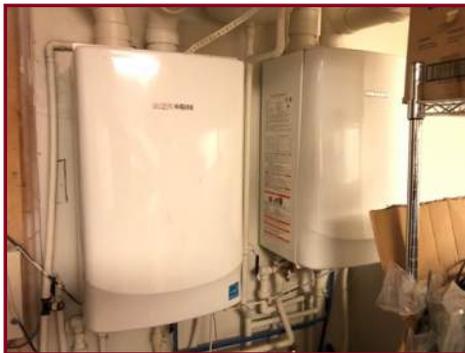
WATER HEATERS

No observed or reported deficiencies were noted.

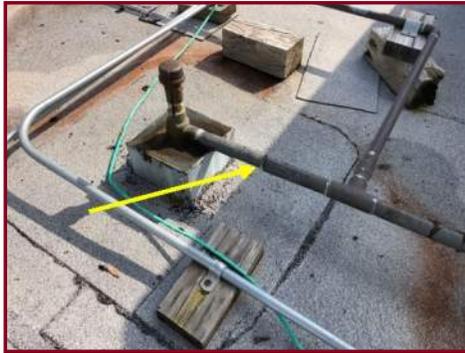
The condensate line draining all four units was observed to be cut in two just before it enters the drain, allowing the condensate to drain onto the roof surface. Condensation from HVAC units should drain to the sanitary sewer. Condition should be further evaluated and corrected as necessary.

CONDENSATE DRAIN HAS BEEN CUT

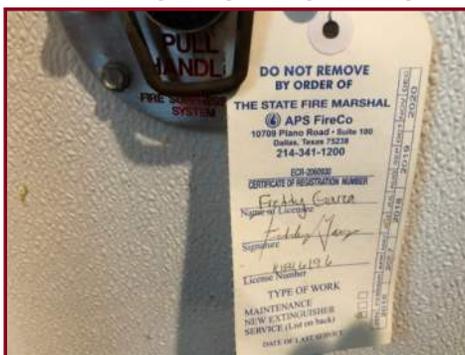
The inspection tag to the pull station for the fire suppression equipment in the kitchen vent hoods was observed to be out of date.

KITCHEN VENT HOOD PULL STATION INSPECTION TAG

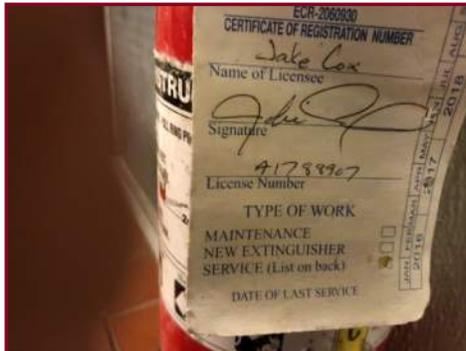
**Inspection Tags were observed to be out of date.**

FIRE EXTINGUISHER INSPECTION TAG

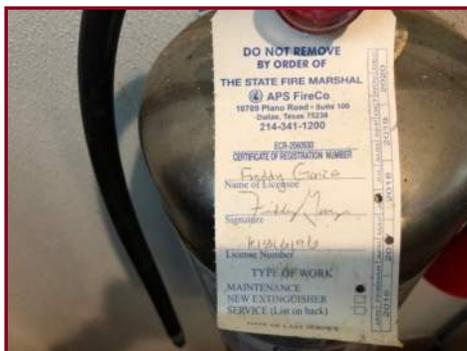
FIRE EXTINGUISHER INSPECTION TAG
