PROPERTY INSPECTION REPORT

Client: John Q. Customer
Inspection Address: 1234 WhataRelief Ln
Inside, TX 75111
Year Built: 2004 - Size: 2,715 square feet

Date of Inspection: 12/19/2019 - Time: 1:00 PM
Weather: Sunny - 60 to 70 degrees

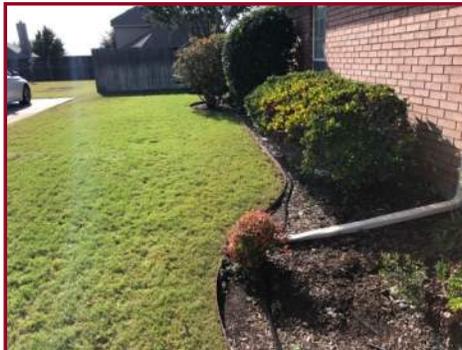
SOIL LINE IS MARGINALLY HIGH ON SOUTH SIDE OF HOUSE

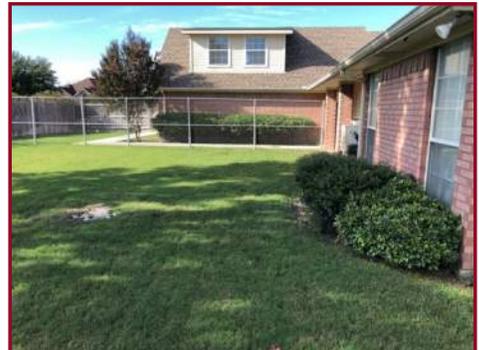
MARGINAL DRAINAGE ON WEST SIDE OF HOUSE

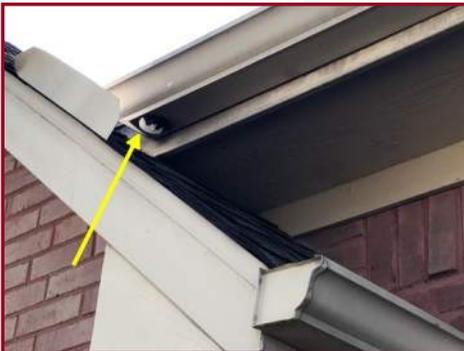
GUTTER NEEDS CLEANING

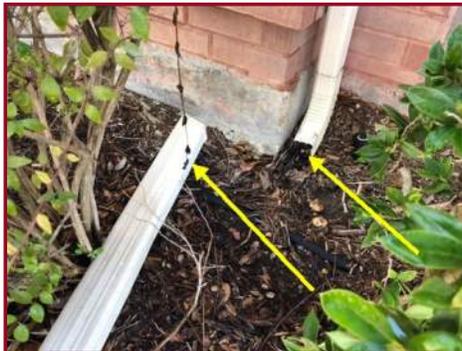
DOWNSPOUT SEPARATED AND CLOGGED WITH LEAVES ON EAST SIDE

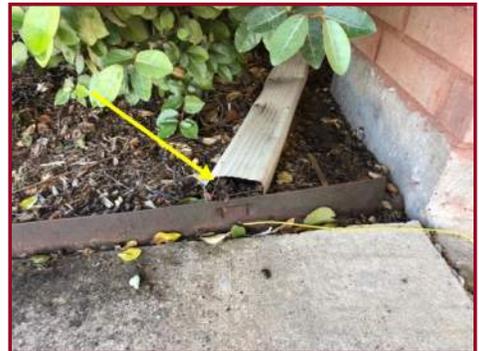
DOWNSPOUT IS CLOGGED ON NORTH SIDE

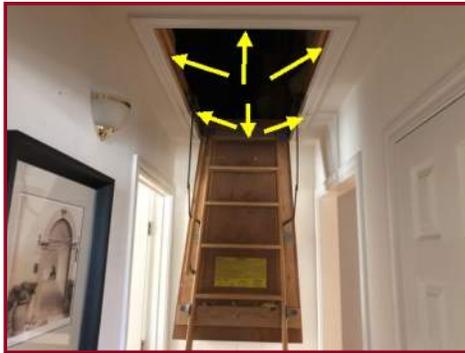
WEATHERSTRIPPING NEEDED AROUND ATTIC LADDER OPENING

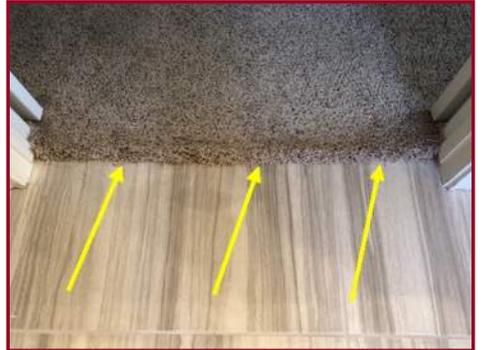
CARPETING NEEDS TO BE STRETCHED AND TUCKED AT MASTER BATHROOM DOOR

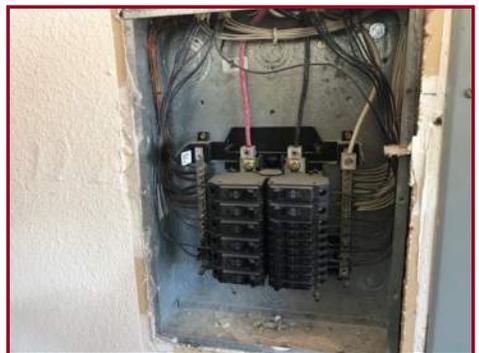
SUB PANEL WITH COVER REMOVED FOR INSPECTION PURPOSES

The dead front cover on the sub panel has missing screws. Recommend replacing the screws that are missing with the correct blunt tip screws

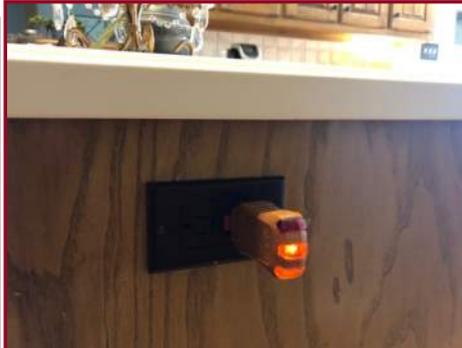
GFCI NOT WORKING PROPERLY ON CENTER ISLAND IN KITCHEN

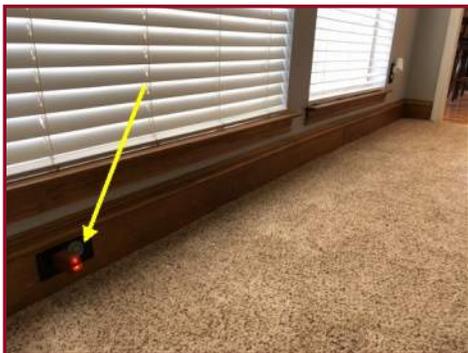
REVERSE POLARITY IN RECEPTACLE ON WEST WALL OF LIVING ROOM

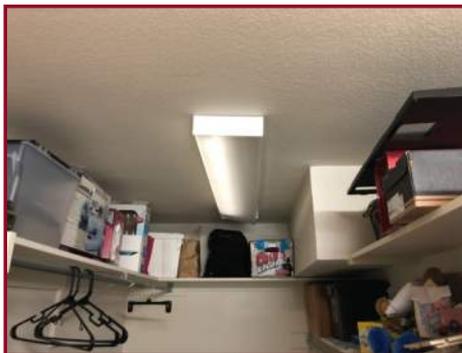
INOPERATIVE LIGHT FIXTURE IN MASTER CLOSET

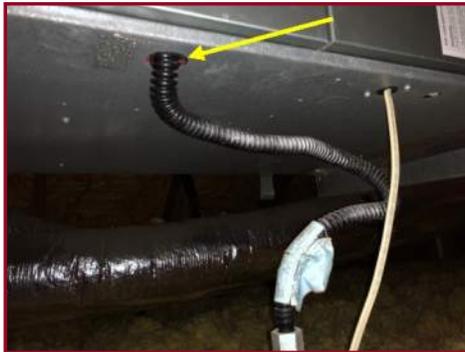
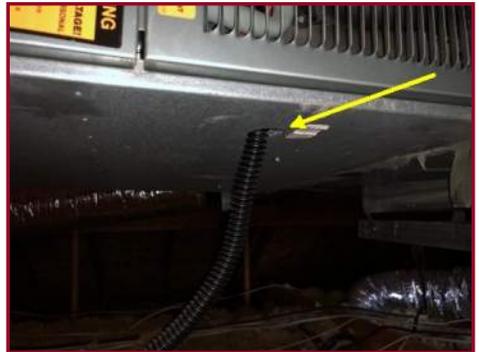
The gas supply flex connector on all three units was observed to be passing through the heating unit cabinet. Under current mechanical installation standards, this is no longer an accepted practice. Only rigid black gas pipe is allowed to pass through the heating unit cabinet.

FLEX CONNECTOR ENTERS CABINET

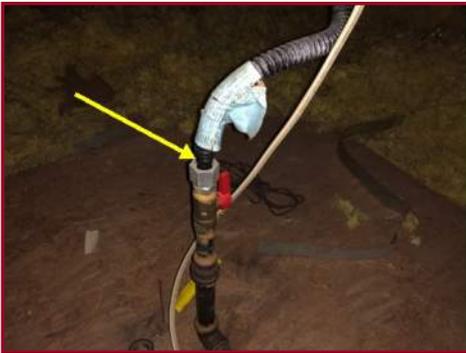
NO SEDIMENT TRAP

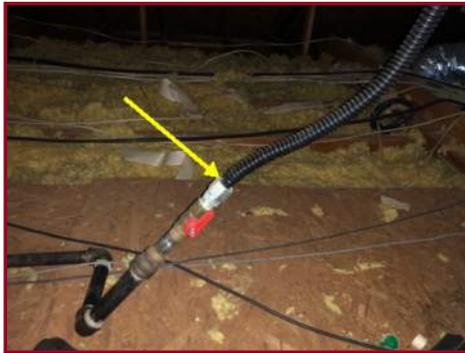
NO SEDIMENT TRAP

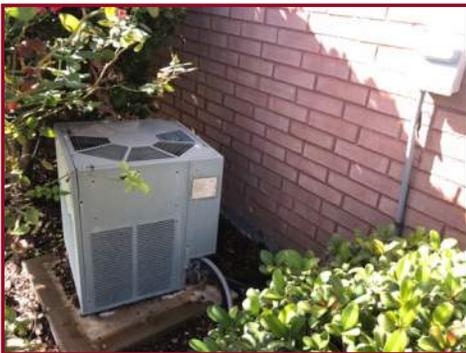
CENTRAL COOLING SYSTEM UNIT #1

The temperature drop measured across the evaporative coils of the cooling system #1 is lower than considered typical. The unit is not cooling properly and servicing is needed.

This **HVAC** system and equipment needs to be checked and serviced by a Qualified / Licensed HVAC Technician. The observations made to support the rendering of this opinion are listed but may not be limited to the following:

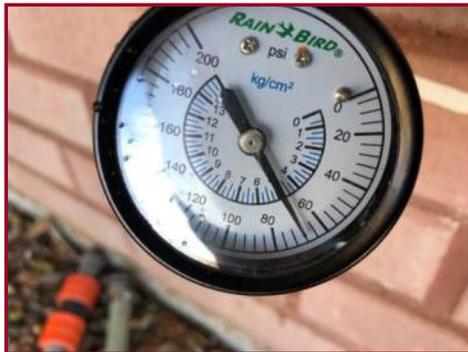
STATIC WATER PRESSURE READING

The shower faucet had low water pressure in the master bathroom. Condition should be further investigated and corrected as necessary.

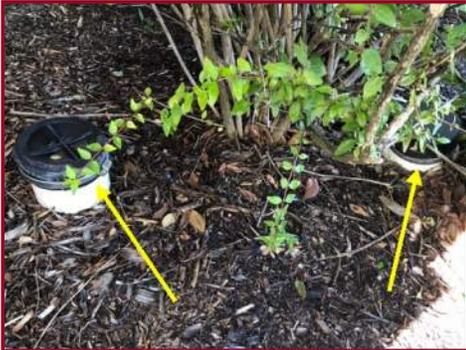
SEWER CLEANOUTS IN EAST FLOWERBED

The plumbing cleanout cover(s) located in the yard were observed to be missing on the North Side of the structure.

The sewer cleanout on the north side was observed to have water flowing out of the top indicating a possible blockage in the sewer line. Condition should be further evaluated and corrected as necessary.

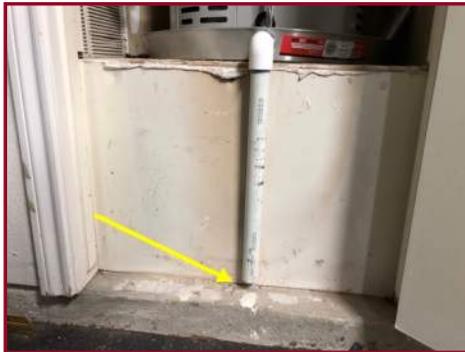
The drain line for the water heater pan was observed to terminate onto the garage floor. The pan drain line should terminate over a suitably located indirect waste receptor or shall extend to the exterior of the building and terminate not less six-inches (6") and not more than twenty-four inches (24") above of the ground. This is an "as-built" condition but Per TREC standards of practice we are required to report this condition as a deficiency

PAN DRAIN LINE TERMINATES IN GARAGE

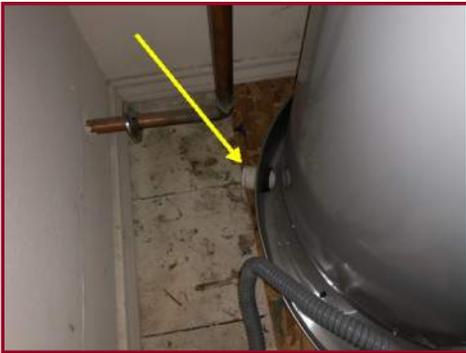
There is no drain line installed for the water heater pan. The pan should have a drain line installed that should terminate over a suitably located indirect waste receptor or shall extend to the exterior of the building and terminate not less six-inches (6") and not more than twenty-four inches (24") above of the ground. This is an "as-built" condition but Per TREC standards of practice we are required to report this condition as a deficiency

NO DRAIN LINE ON DRAIN PAN

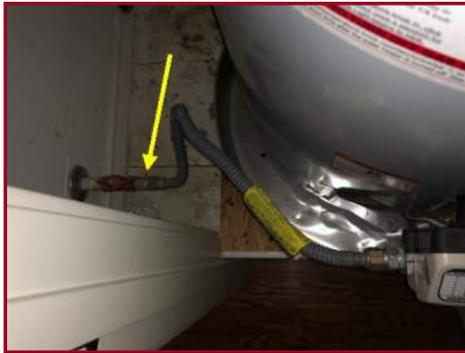
The water heater gas supply line is not equipped with a sediment trap just before the gas appliance connector. This condition does not meet current installation requirements. This is an "as-built" condition and may not have violated building codes or common practices at the time of the construction of the home, or they may have been "grandfathered" because it was present prior to the adoption of codes prohibiting such conditions, but Per TREC standards of practice we are required to report this condition as a deficiency. Some items reported as Deficient may be considered upgrades to the property. For more information, refer to Texas Real Estate Consumer Notice Concerning Recognized Hazards, form OP-1.

NO SEDIMENT TRAP

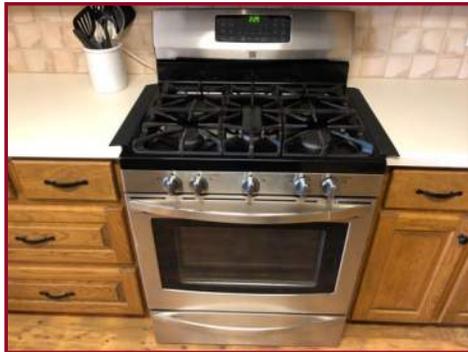
RANGE

Children can tip the oven over if the door is used as a stepping stool. All ovens are now required to be secured in some fashion. An **anti tip** device should be installed for safety.

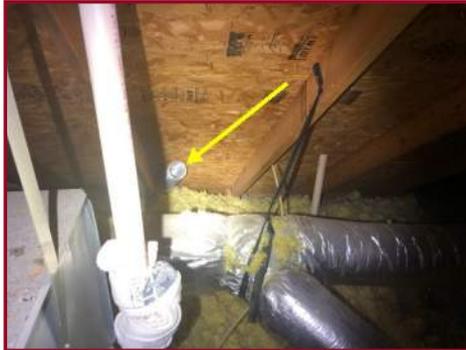
The mechanical exhaust vents were observed to be venting into the attic area. Under current building standards, all mechanical exhaust vents should vent to the exterior of the structure. This is an "as-built" condition and may not have violated building codes or common practices at the time of the construction of the home, or they may have been "grandfathered" because it was present prior to the adoption of codes prohibiting such conditions, but Per TREC standards of practice we are required to report this condition as a deficiency. Some items reported as Deficient may be considered upgrades to the property. For more information, refer to Texas Real Estate Consumer Notice Concerning Recognized Hazards, form OP-1.

MECHANICAL EXHAUST VENTS EXIT INTO ATTIC
