PROPERTY CONDITION REPORT

Client: Ultimate Properties
Property: 9091 Somewhere Ln, Dallas, TX 76493
Year Built: 2020 - Size: 83,376 square feet

Date of Inspection: 12/1/2020 - Time: 11:00 AM
Weather: Sunny - 50 to 60 degrees

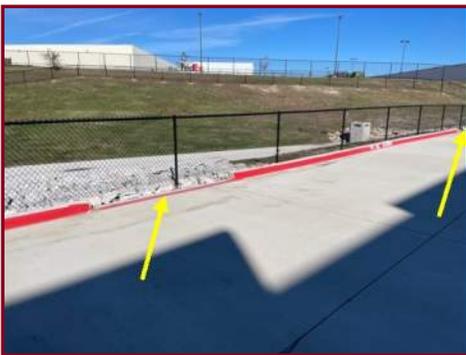
NORTH DRIVE STORM DRAINAGE

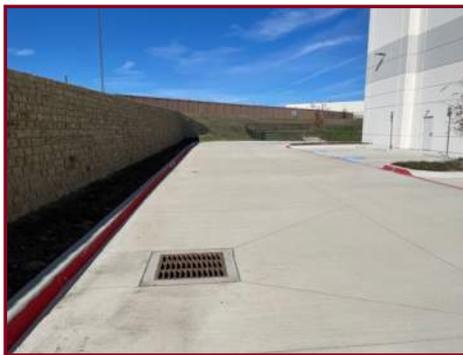
WEST DRIVE STORM DRAIN

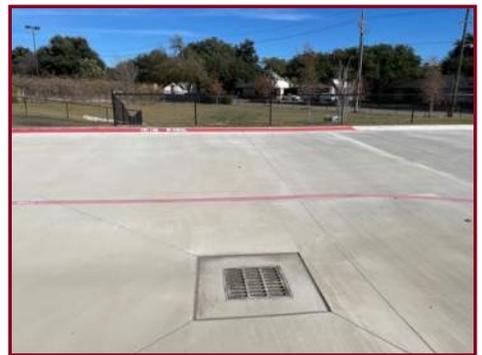
STORM DRAIN IN EAST DRIVE

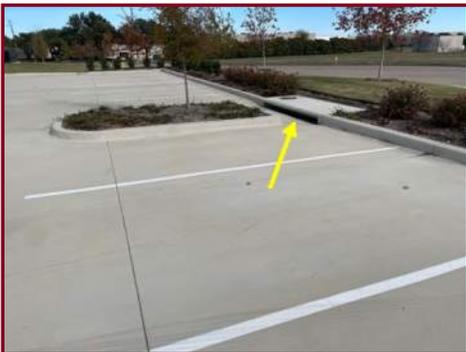
STORM WATER DRAIN IN FRONT PARKING LOT

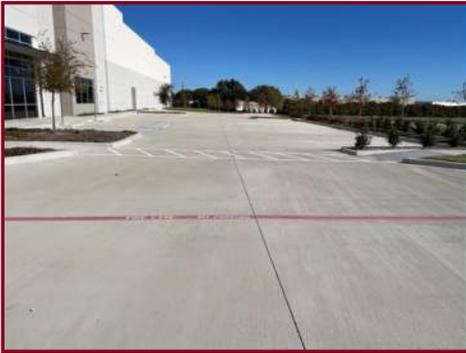
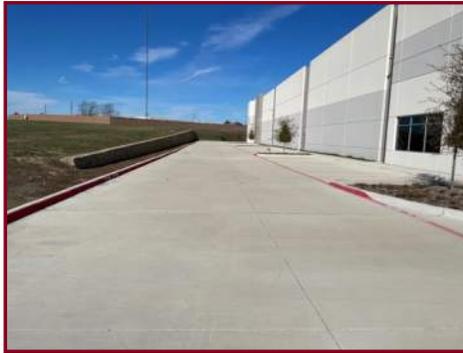
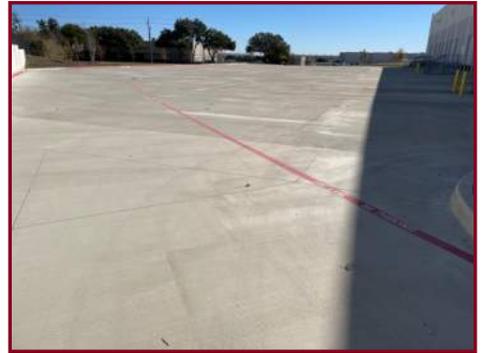
The curbing was observed to be cracked/damaged on the south end of the truck bay parking lot. Condition should be further evaluated and corrected as necessary.

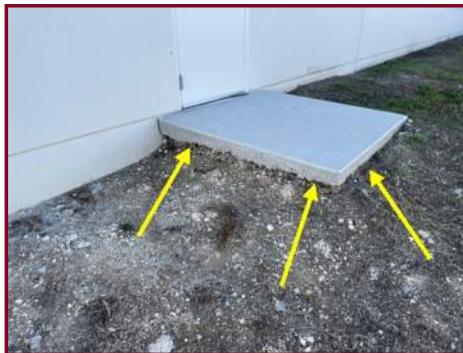
Ground erosion has occurred under the stoop at the northeast corner of the structure. Fill dirt is needed against the edge of the concrete to prevent undermining and settling of the sidewalk.

EROSION UNDER NORTHEAST EXIT DOOR STOOP

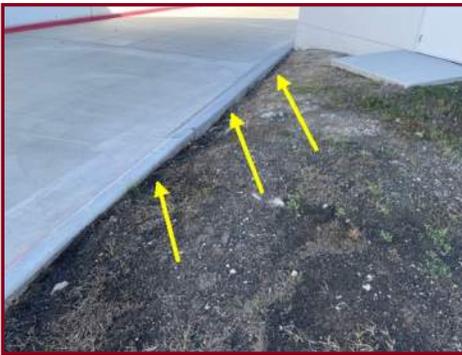
Erosion was observed at the foundation at the northeast corner of the structure. Fill dirt and foliage should be installed to prevent possible foundation settlement.

FILL DIRT REQUIRED AGAINST CURB AT NORTHEAST CORNER

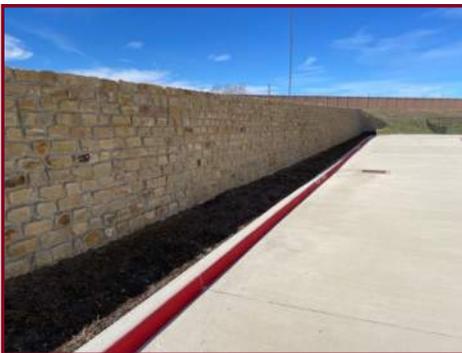
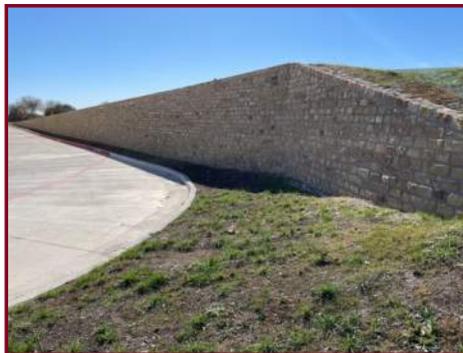
WEST RETAINING WALL

The item retaining walls appear to be performing their intended function, achieving an operation, function or configuration relative to accepted industry standard practices with consideration of age and normal wear and tear from ordinary use at the time of the inspection

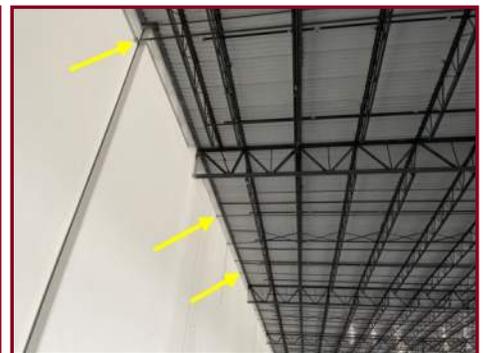
HORIZONTAL BRIDGING IS PROPERLY TIED TO EXTERIOR WALLS

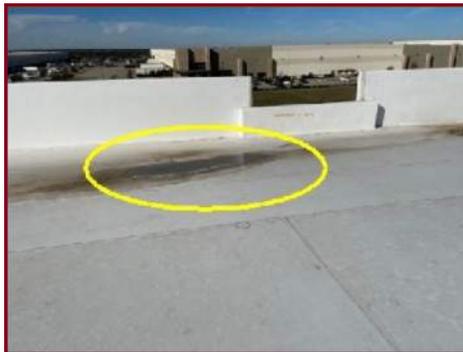
The flat roof area has standing water in various locations. Flat roof structures should not hold water more than 24-hours. This condition should be closely monitored and improved as necessary.

STANDING WATER ON WEST SIDE

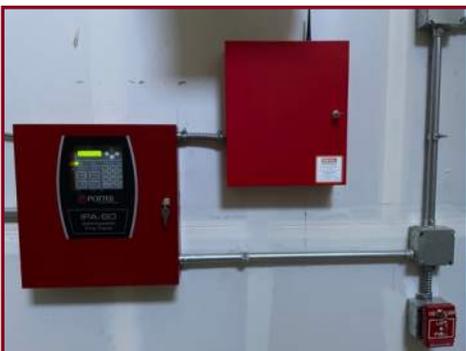
SPRINKLER ALARM CONTROLS

Inspection Tags were not found.
